CASE STUDY: MINING – IRON ORE

BHP HYDROCYCLONE SYSTEMS: SIDE BY SIDE

CASE STUDY: BHP HYDROCYCLONES

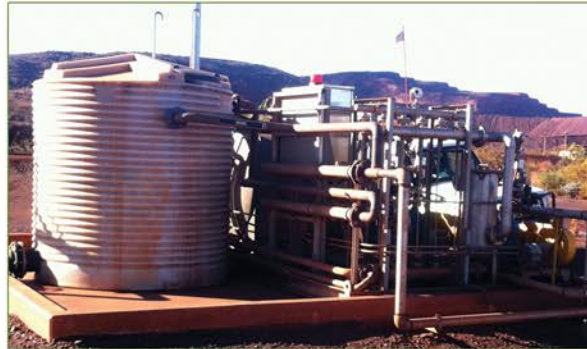
BHP WHEELARRA MINE SITE

Average 55mg/L TPH

Was not in compliance

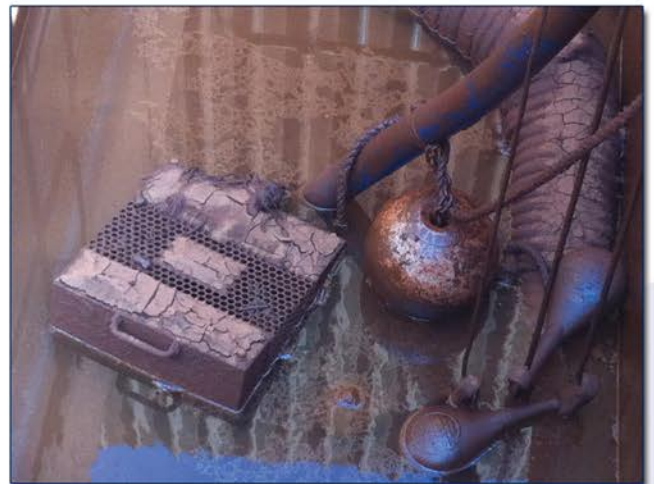
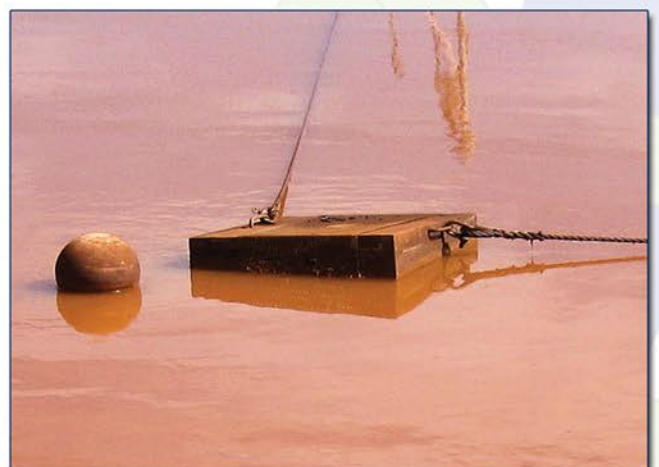
ALTERNATE HYDROCYCLONE

The oily water skimmer chosen by the alternate vendor was ineffective at removing oil and prone to blockage by debris. BHP personnel confirm that the alternate skimmer needed to be removed every two weeks to remove debris and clear blockages.

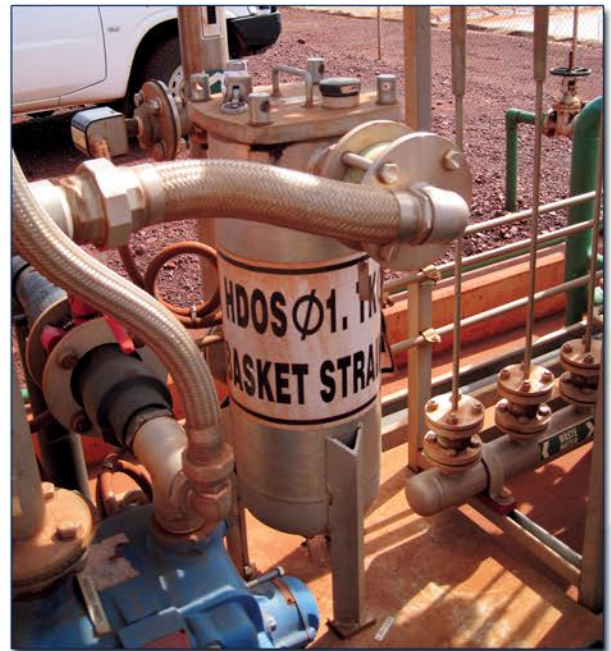
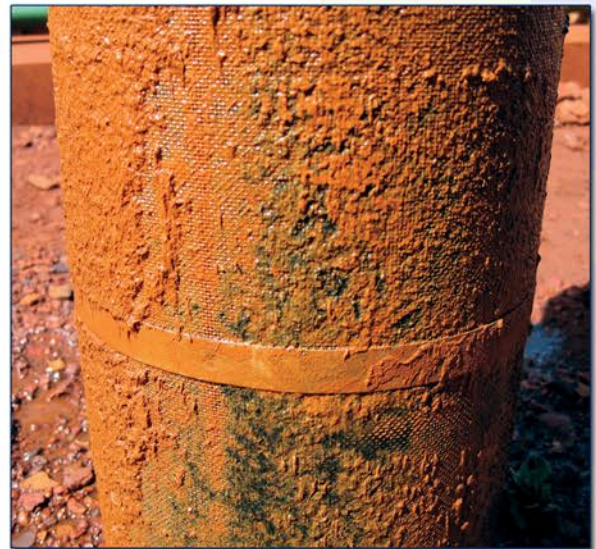
ALTERNATE HYDROCYCLONE

The alternate water strainer was too small and BHP site personnel were forced to clean the alternate basket strainer every two weeks in order for the system to keep operating. In addition, the basket design was poor and cleaning was a very difficult task.
