# CASE STUDY: MINING – IRON ORE

## RIO TINTO MARANDOO

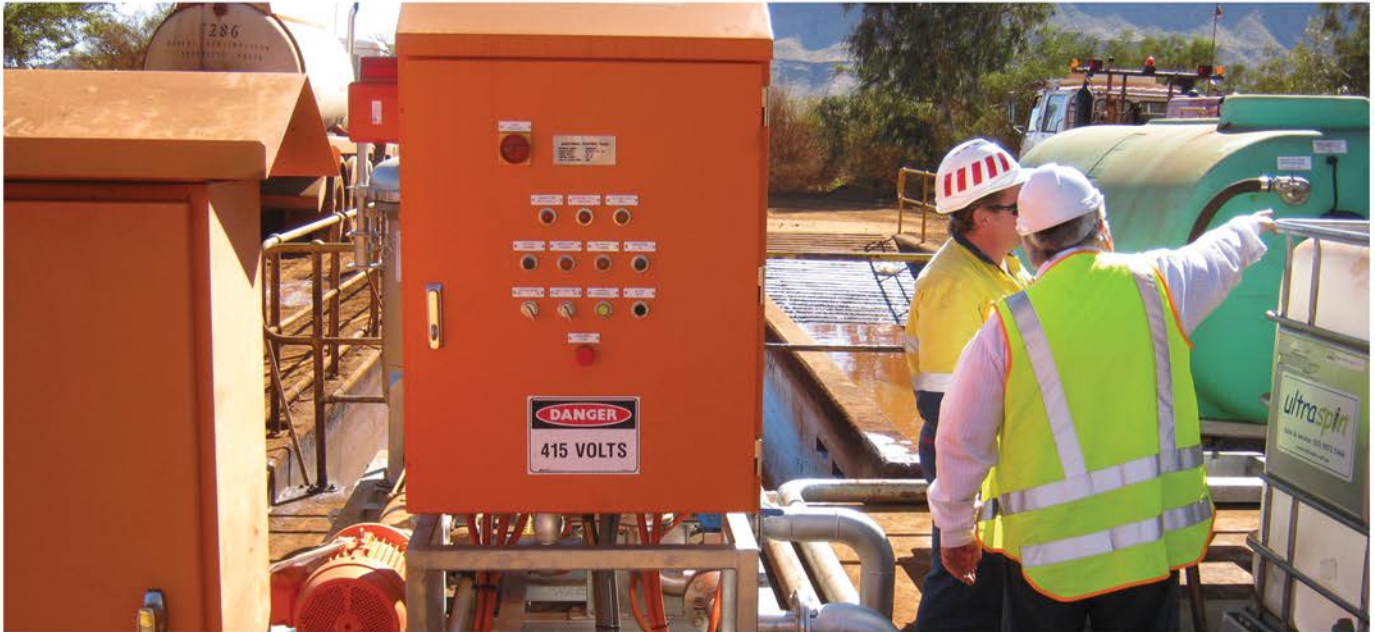
*Commissioning in July 2010*

ES25 Oily Water Separator (25m<sup>3</sup>/h) package

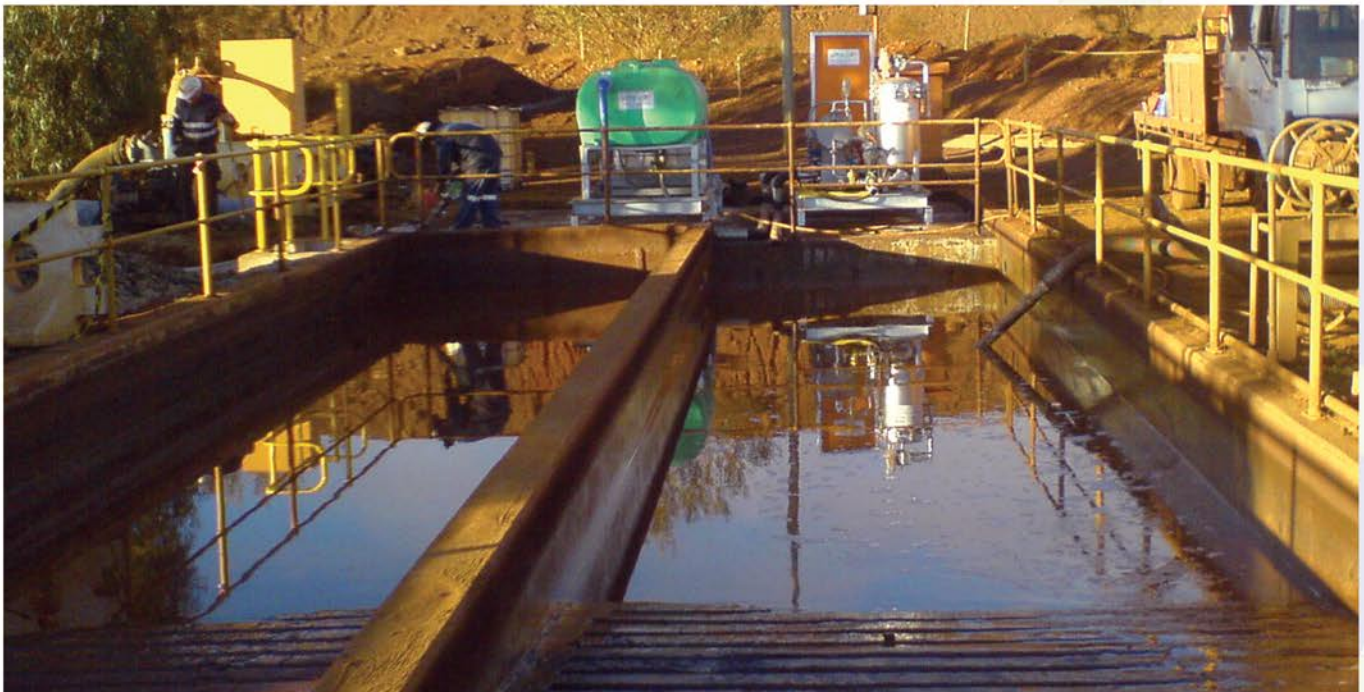
*Site Overview*
